Results of Architectural Paint Research to the exterior of 9 Conduit Street, Mayfair

November 2019

SKETCH, 9 CONDUIT STREET, MAYFAIR

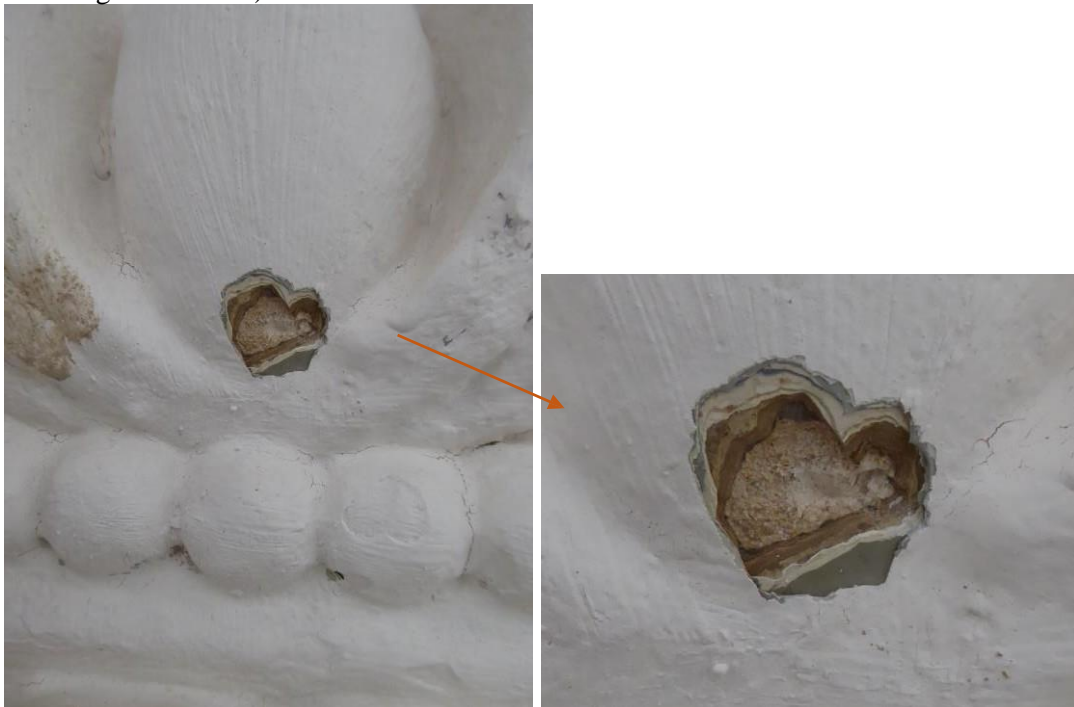
The following image taken from the egg and dart moulding from the capital between the second and third storeys shows the extent of the thickness of the paint films (including a closeup detail to the right-hand side)

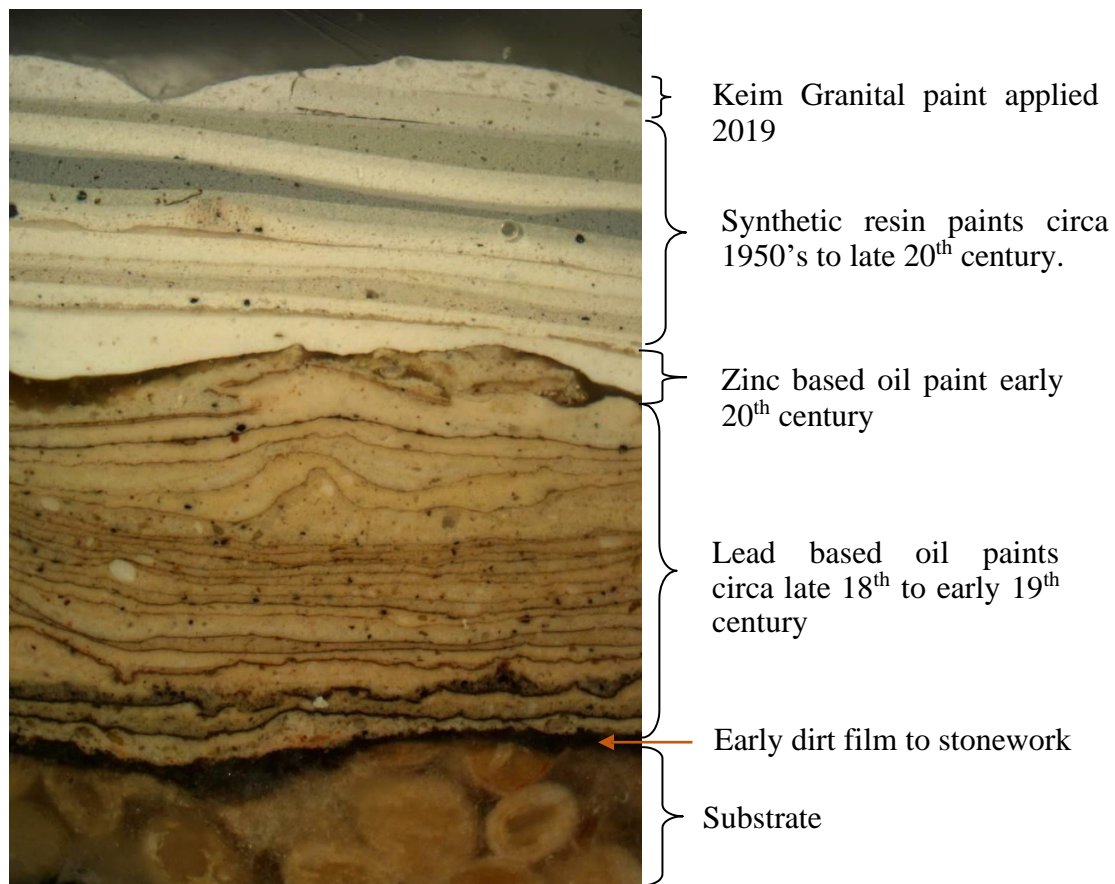
Figure 1: Sample 23 from the capital to the second floor

The photomicrograph shown overleaf represents the sample taken from the Ionic capital to the upper storeys to the façade of the building and shows the extent of the surviving lead-based oil paints. It should be stated that it is not known how many schemes of decoration have been removed as part of the paint removal process prior to the conservators visit.

Exposure of the decorative schemes by careful uncovering of the paint films has not been included in the scope of works due to the unknown extent of surviving paint films prior to sampling. Where further removal of paint archaeology is to be proposed then this recording should be undertaken prior to further paint stripping.

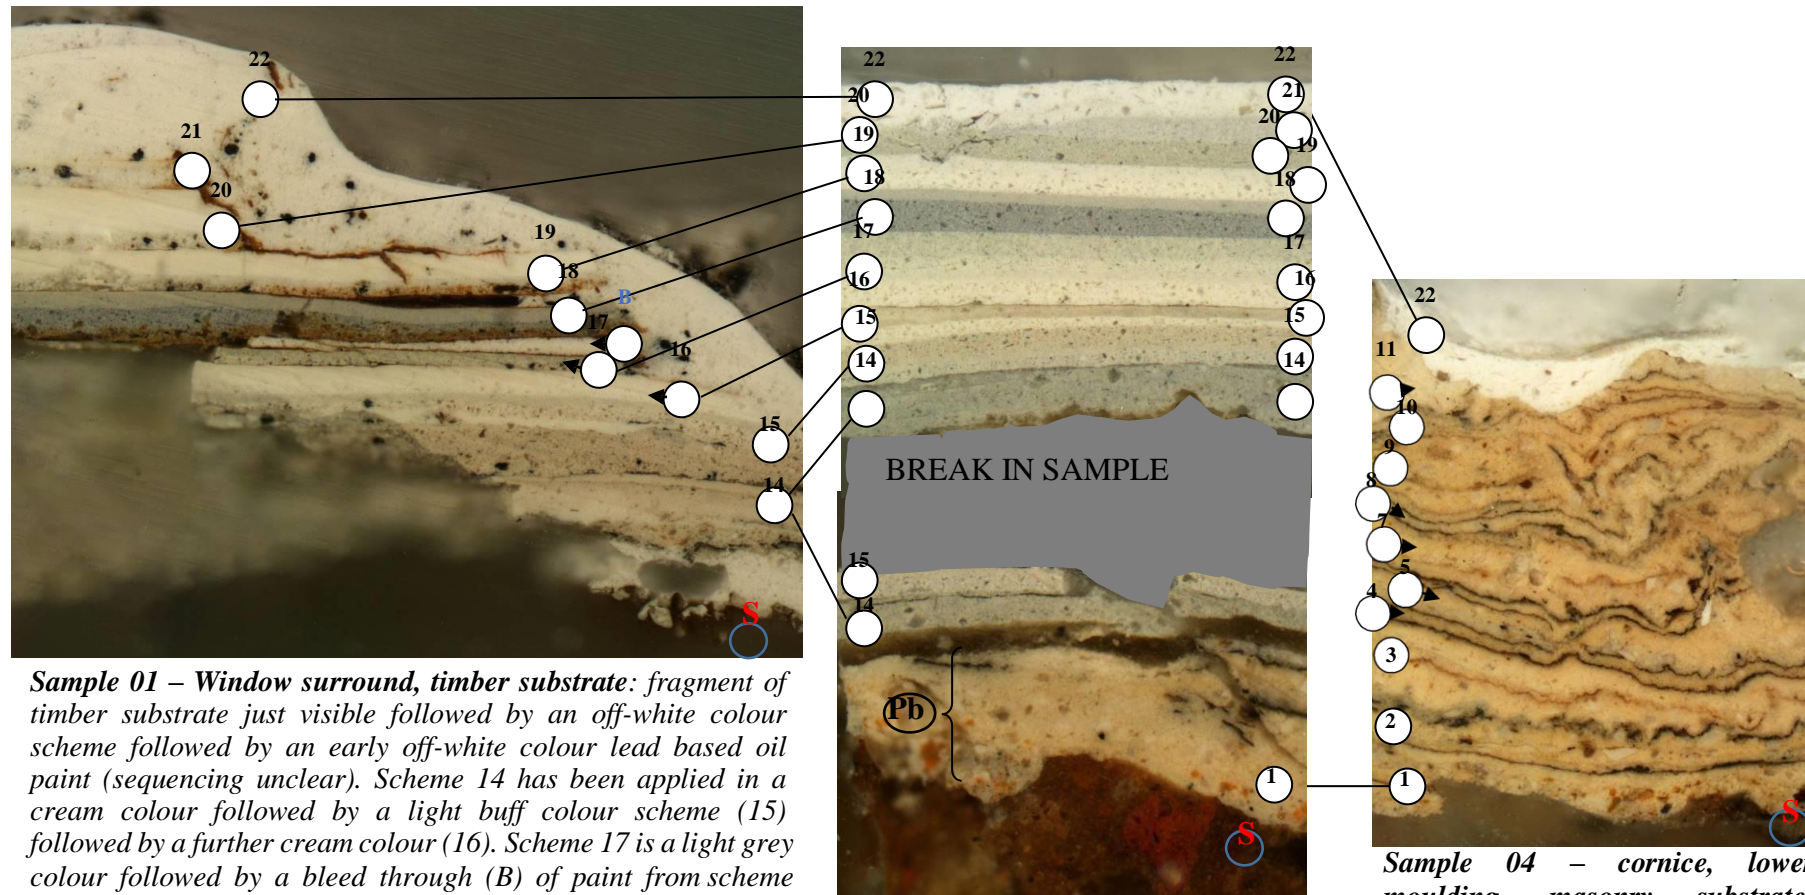
Sample 01 – Window surround, timber substrate: fragment of timber substrate just visible followed by an off-white colour scheme followed by an early off-white colour lead based oil paint (sequencing unclear). Scheme 14 has been applied in a cream colour followed by a light buff colour scheme (15) followed by a further cream colour (16). Scheme 17 is a light grey colour followed by a bleed through (B) of paint from scheme 22 getting into a fracture between earlier paint films. Scheme 18 is a darker grey colour followed by a return to a cream colour (19), remaining schemes have been applied in off- white colour paint (20 – 22). Disruption in paint films noted with dark brown films seen to later schemes, evidence of possible preparatory coat.

Sample 02A & B – render to side of column, masonry substrate: masonry substrate visible (S) followed by initial stone colour scheme (01) followed by a further stone colour (scheme number not identified) this is followed by a light grey colour (14) followed by a buff colour scheme (15) and a cream colour scheme (16). Scheme 17 has been applied in a light grey colour followed by a dark grey colour scheme (18). This is followed by an off-white colour (19) followed by two further grey colour schemes (20 & 21) followed by an off-white colour scheme (22). Earliest scheme applied in lead-based oil paint.

Sample 04 – cornice, lower moulding, masonry substrate: substrate just visible (S) followed by 11 schemes of stone colour lead based oil paint. Schemes are disrupted and distorted in some areas due to softening by paint stripped and location of sample. Stone colour schemes followed by a cream colour scheme (22)

- Sample 01 was taken from the area below the hinge to an upper floor window where a good amount of paint was visible. The sample contains a small amount of lead-based oil paints but also dark brown films within the later schemes. These are not varnish films as there is no reaction to ultra-violet (UV) light nor is there a reaction in UV light to any pigments contained in these films.

- Sample 02 has split so schemes 14 and 15 appear twice. Earliest scheme (01) contains red lead pigments but the scheme that follows it is too disrupted to clearly identify sequence number (could be scheme two identified by the dark film below and above the paint film).

- Sample 04 retains a significant number of early lead-based oil paint schemes but has lost the later schemes through the paint stripping prior to the sampling being undertaken.

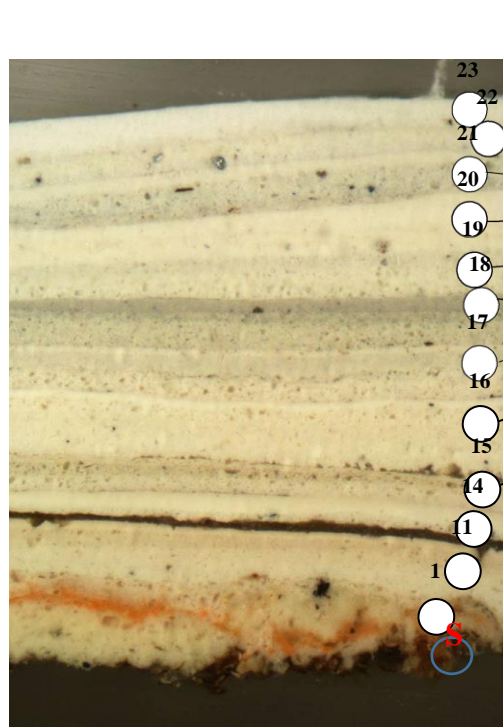
Sample 17 – window surround, timber substrate: timber substrate just visible

(S) followed by first scheme with distinct orange section (red lead pigment) (1), this is followed by scheme 11 applied in an off-white/buff colour. Schemes then jump to scheme 14 also applied in off-white, followed by three further schemes of off-white/buff colour (15 – 17), scheme 18 changes to a grey colour followed by a light grey colour at scheme 19. Scheme 20 returns to an off-white colour followed by a further grey colour scheme (21) followed by two further off-white colour schemes (22 & 23).

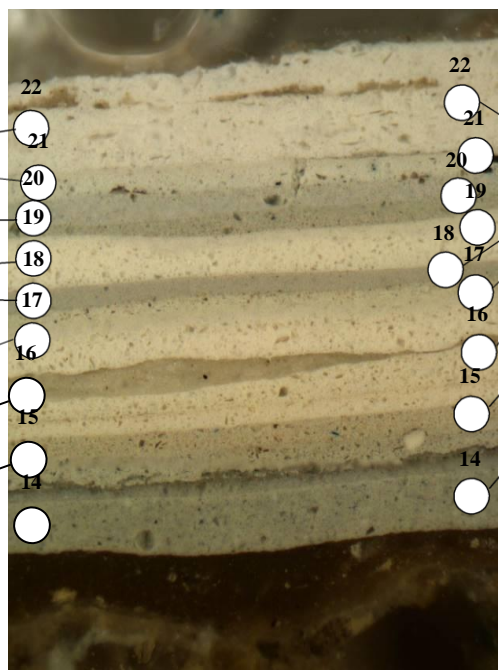
Sample 18 – window reveal, masonry substrate: Masonry substrate just visible (S) with a preparatory coat applied beneath a grey colour scheme

(14) this is followed by a light grey/buff colour (15) followed by an off-white colour (16). Scheme 17 is a pale grey colour followed by a further grey colour (18). Scheme 19 returns to an off-white colour followed by a further grey colour scheme (20) and a pale grey scheme (21). Scheme 22 has been applied in an off-white colour – further schemes disrupted by paint stripper. No lead-based oil paint seen.

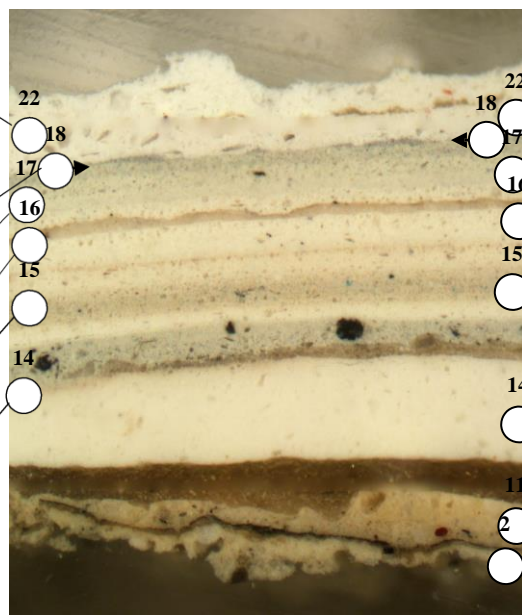
Sample 19 – fluted band beneath window, substrate missing: masonry substrate not seen. Fragment of scheme earliest scheme visible (02) followed by a

preparatory coating applied beneath scheme 14 applied in a cream colour zinc-based oil paint. Scheme 15 has been applied in a buff/grey colour followed by an off-white colour (16) this is followed by a further light grey colour (17) and a further darker grey colour (18). The next scheme (22) has been applied in a cream colour. First two schemes have been applied in lead-based oil paints.

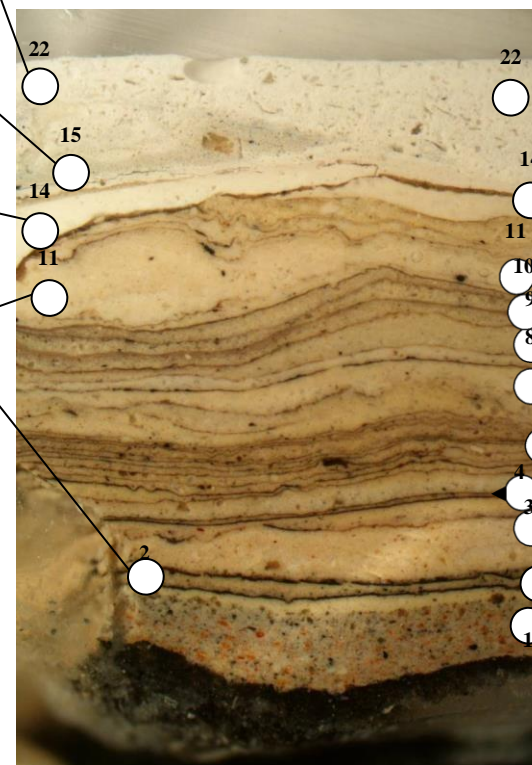
Sample 20 – lion head moulding to capital, substrate not identified: initial dark grey colour base followed by a stone colour paint film (01) applied over a densely pigmented base coat (black and red lead pigments). This is followed by 16 successive stone colour schemes applied in lead-based oil paints. Scheme 14 changes to a cream colour (zinc-based oil paint). Paint films have then been disrupted with scheme 15 (buff/grey colour) just visible followed by scheme 22 applied in a cream colour.

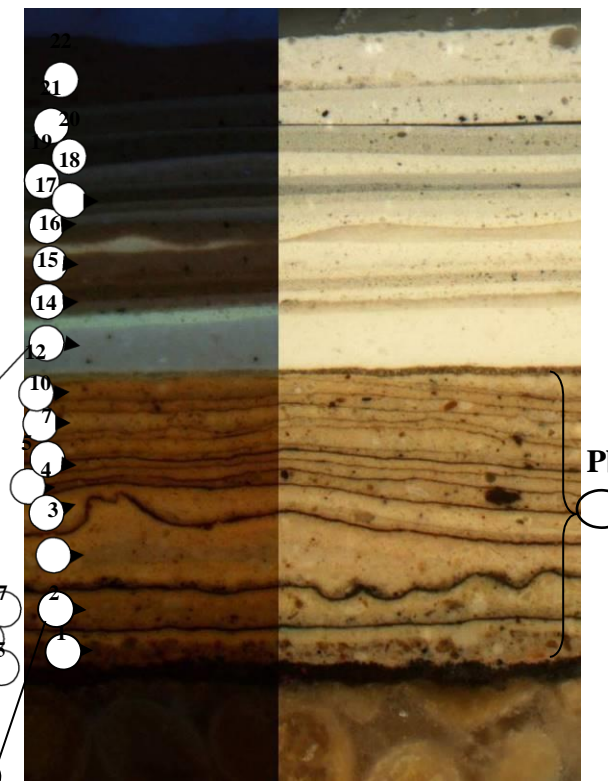
Sample 22 – egg and dart to capital, masonry substrate: stone substrate with visible dirt film followed by a stone colour paint film (01) over a densely pigmented base coat (black and red lead pigments). This is followed by 11 further stone colour schemes applied in lead-based oil paints. Scheme 14 is a cream colour (zinc-based oil paint) followed by the buff/grey colour scheme 15. Scheme 16 has been applied in a cream colour followed by the first grey colour scheme (17) repeated in a darker grey (18) followed by an off-white colour scheme (19) followed two further grey colour scheme (20 & 21) with an off-white colour at scheme 22.

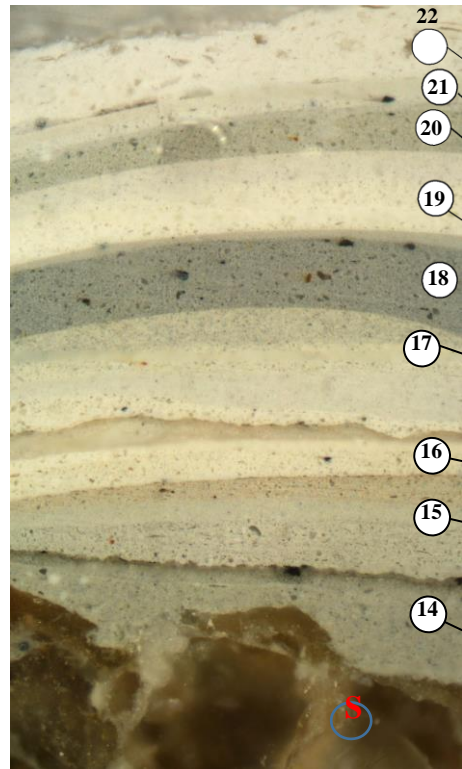
Sample 06 – 1st floor window, frieze above window (also representative of samples 05, 08, 27), masonry substrate: first scheme seen has been applied in a grey colour zinc-based oil paint (14) followed by a further buff/grey colour scheme (15). Colour then changes to an off-white scheme

(16) followed by a further light grey colour (17). Scheme 18 has been applied in a dark grey colour, followed by a return to a cream colour (19). Scheme 20 has been applied in a grey colour followed by two further cream colour schemes (21 & 22). No lead-based oil paints were seen to the sample.

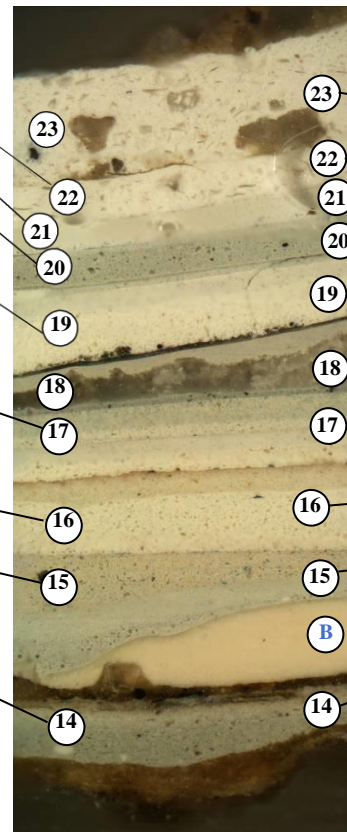
Sample 09 – render to façade, substrate missing: first scheme seen has been applied in a grey colour (14) followed by the buff/grey colour scheme (15) followed by a cream colour scheme

(16). Scheme 17 has been applied in a light grey colour followed by a further light grey scheme (18) and a light grey colour at scheme 19. Scheme 20 has been applied in a darker grey colour before three schemes of a cream colour (21 – 23). No lead-based oil paints were seen in the sample.

- Some evidence of a bleed through of paint films seen in sample 09, represented by a B in the analysis above, this is as a result of a fracture in the earlier paint films and a later application of paint bleeding (seeping) into the void created by the fracture.
- Comparable use of colour seen across the samples in the later schemes, although some samples are missing the earliest stone colour lead-based oil paints seen to samples from the render as opposed to the decorative elements such as the column.
- Evidence of disruption to later schemes seen most likely due to the use of paint stripper but this cannot be confirmed from the samples taken.

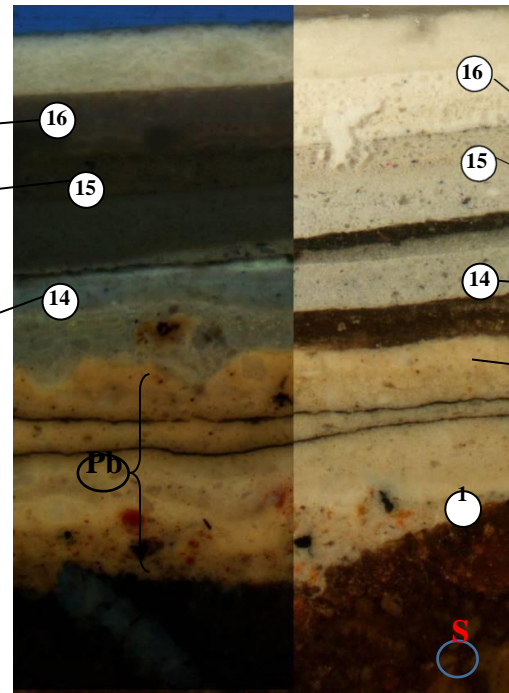
Sample 07A – (combined UV image) – side of window pediment, masonry substrate: fragment of first scheme seen (01) applied in a stone colour lead-based oil paint followed by earlier stone colour but unable to distinguish scheme due to interruption in paint films (possibly scheme 3). Evidence of a priming layer then seen beneath scheme 14 (zinc-based oil paint) applied in a light grey colour, followed by the buff/grey colour (15) and off-white colour (16).

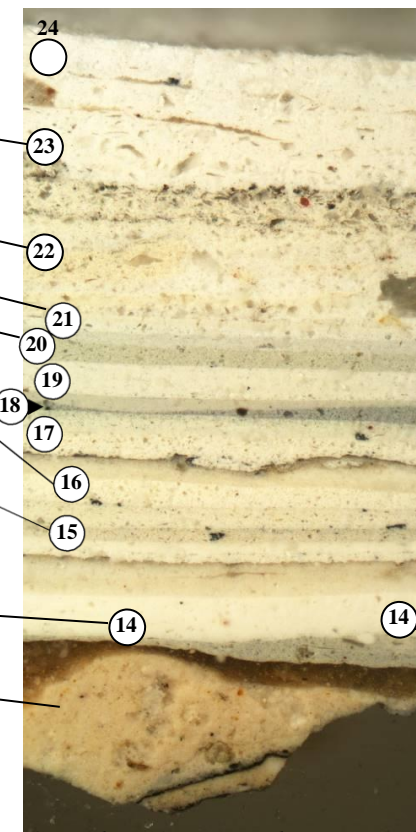
Sample 12B – column, ovolo moulding to base, substrate not shown, (also representative of sample 11): shown to the right - earliest paint films are fragment of stone colour lead based oil

paint with primer applied over prior to the application of scheme 14 with a light grey undercoat and cream colour top coat. Scheme 15 is the buff/grey colour followed by further cream colour (16) then further light grey colour (17). Fragment of dark grey colour scheme (18) followed by cream colour (19) and further grey scheme (20 & 21). Schemes 22 – 23 have been applied in off-white colour.

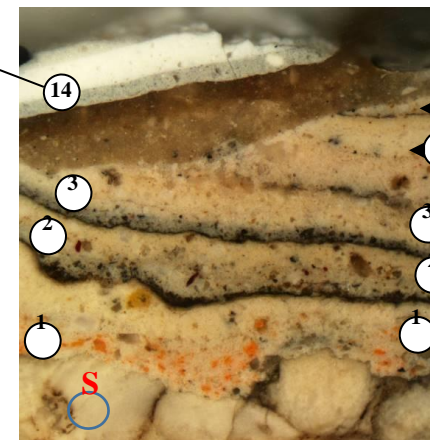
Sample 12A – column, masonry substrate: granular substrate just seen (S) followed by first scheme (01) applied in lead-based oil paint with notable red lead pigments, heavy dirt film over followed by further stone colour schemes (02 – 05). All applied in lead-based oil paints. These are followed by a priming coat prior to the application of scheme 14 (zinc-based oil paint) with a grey undercoat and an off-white top coat. No further scheme seen in sample.

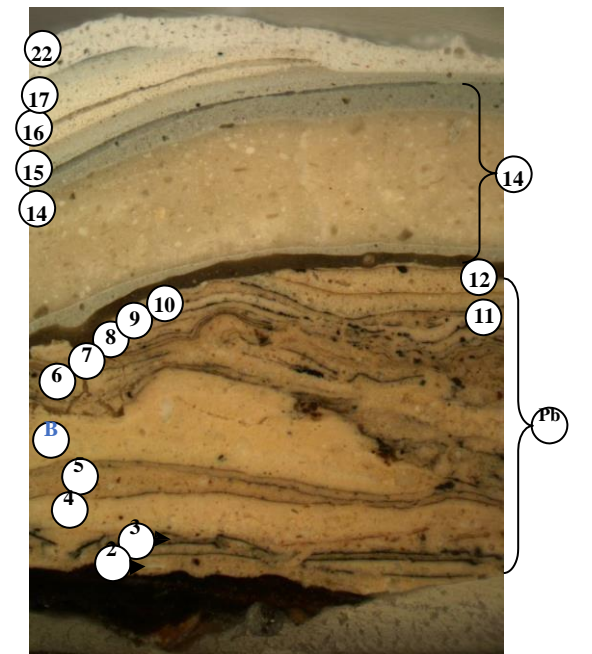
Sample 13 – base of column (vertical flat) substrate missing: initial dark preparatory layer beneath the earliest stone colour lead-based oil scheme (02). Scheme 01 not seen. Up to 11 further schemes of stone colour lead oil paints seen but films are disrupted so exact structure unclear. Priming layer seen beneath scheme 14, applied in a grey colour zinc-based oil paint followed by a further grey scheme (15) and cream colour (16) and a further grey colour scheme (17). Extant is scheme 22, applied in a

cream colour.

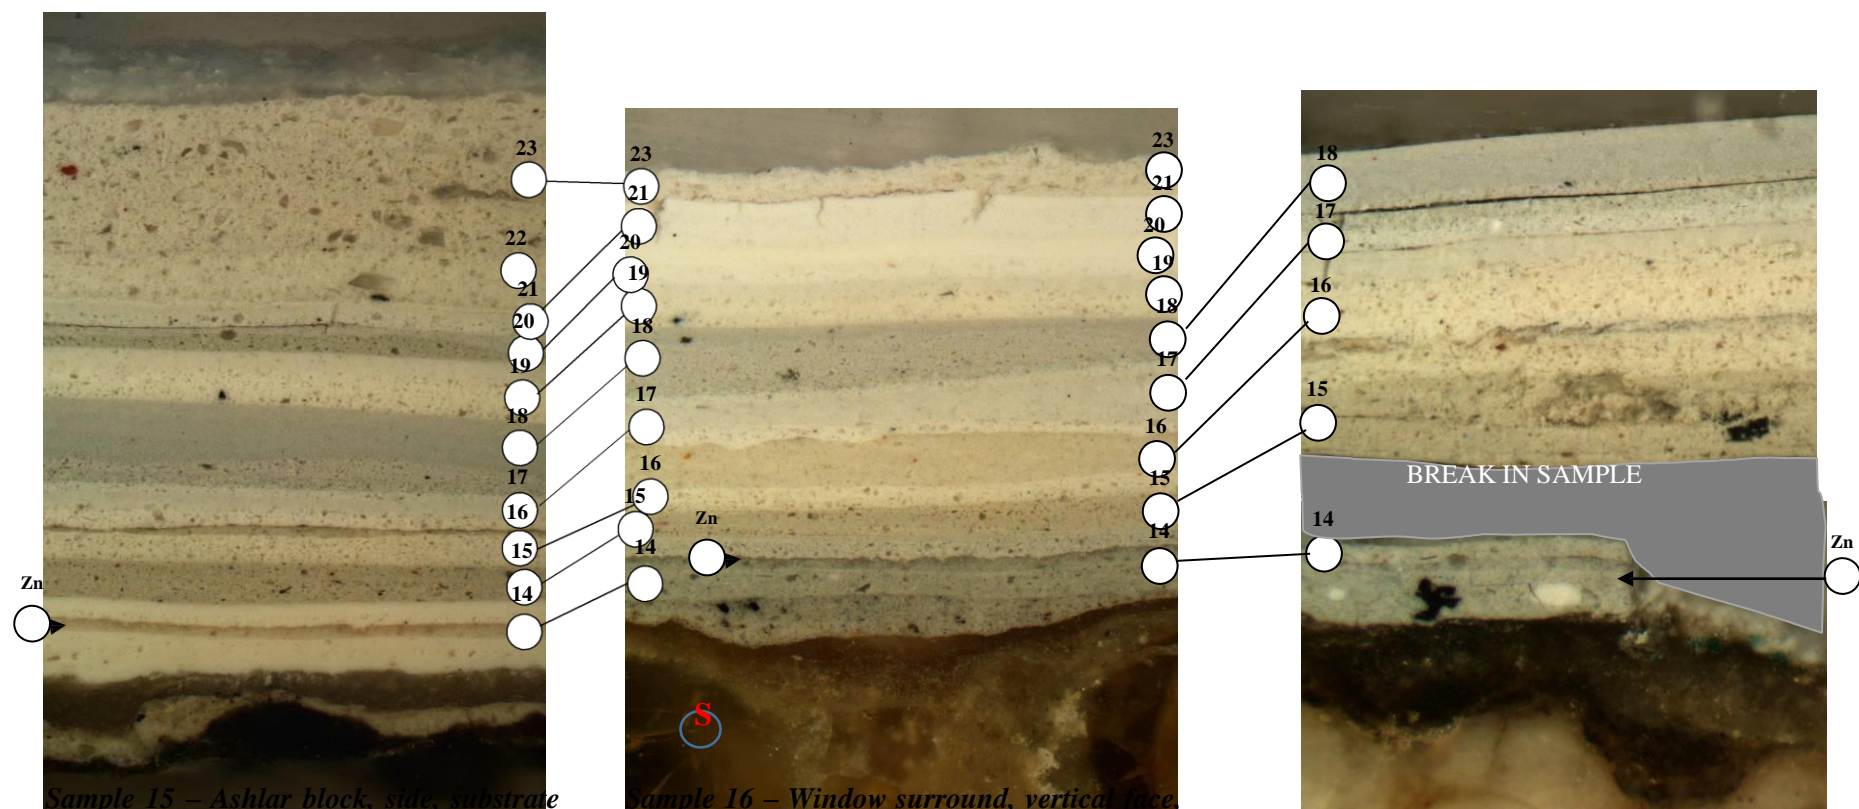
Sample 15 – Ashlar block, masonry substrate
missing: initial cream scheme applied in zinc-based oil paint (14) followed by a grey colour scheme (15) followed by a further cream colour scheme (16). Scheme 17 has been applied in a light grey colour followed by a further dark grey (18) and an off-white colour (19), scheme 20 returns to a grey colour, repeated in a light grey (21). Schemes 22 and 23 have been applied in cream and buff colours. No lead-based oil paints found in sample.

Sample 16 – Window surround, vertical face
masonry substrate: first scheme seen is the grey colour zinc-based oil paint (14) followed by the grey/buff colour scheme (15) this is followed by a cream colour scheme (16) followed by a light grey colour scheme (17). Scheme 18 is a darker grey colour followed by three schemes of cream/off-white colour (19 – 21) which are followed by a buff colour (23). No lead-based oil paints were seen in sample.

Sample 25A, B & C – side of front entrance, masonry substrate: (sample split). Initial scheme seen is the grey colour zinc-based oil paint (14) followed by the grey/buff colour (15), this is followed by a cream colour scheme (16) prior to the application of a further light grey colour scheme (17) followed by a further grey colour scheme (18). Later paint films missing from sample. No lead-based oil paints seen in sample.

- No early lead-based oil paints seen in the samples taken from the ground floor. This implies that earlier failure of paint films or removal of paint films has been undertaken prior to redecoration.
- Earliest paint scheme seen to building corresponds to scheme 14, this has been applied in both cream and grey colours indicating some use of colour to pick out features from the Ashlar block (sample 15) which appears to be a cream colour with window arches and entrance using a grey colour. This is the only notable variation in the use of colour seen to the samples taken from the ground floor facade.
- An incomplete number of schemes were seen to the samples taken from the entrance and those from the Ashlar block. This may be a result of weathering, failure of paint films or removal of paint films as part of the preparation of surfaces prior to redecoration.

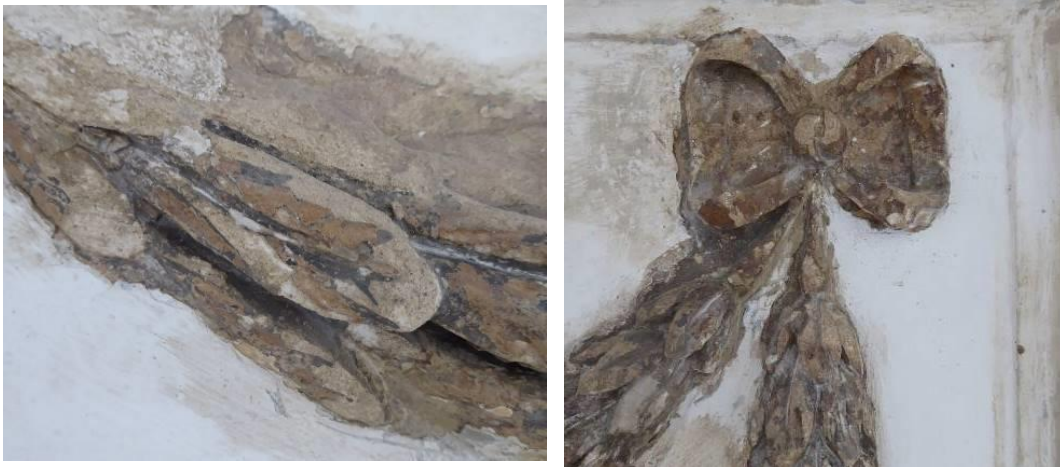
Figure 2: two images from the frieze to the second floor

The impact to façade from the pollution is likely to have resulted in the building being painted a cream colour. This was repeated a number of times in the lead-based oil paints. There is some indication within some of the lead-oil schemes of the use of a warm orange colour wash (similar to a copperas effect). Although the paint films have discoloured with age this can just be detected in the swag moulding decoration to the frieze (see images below).
